Us Coatings Corporation

Case Study

Brewery Floor Rehab

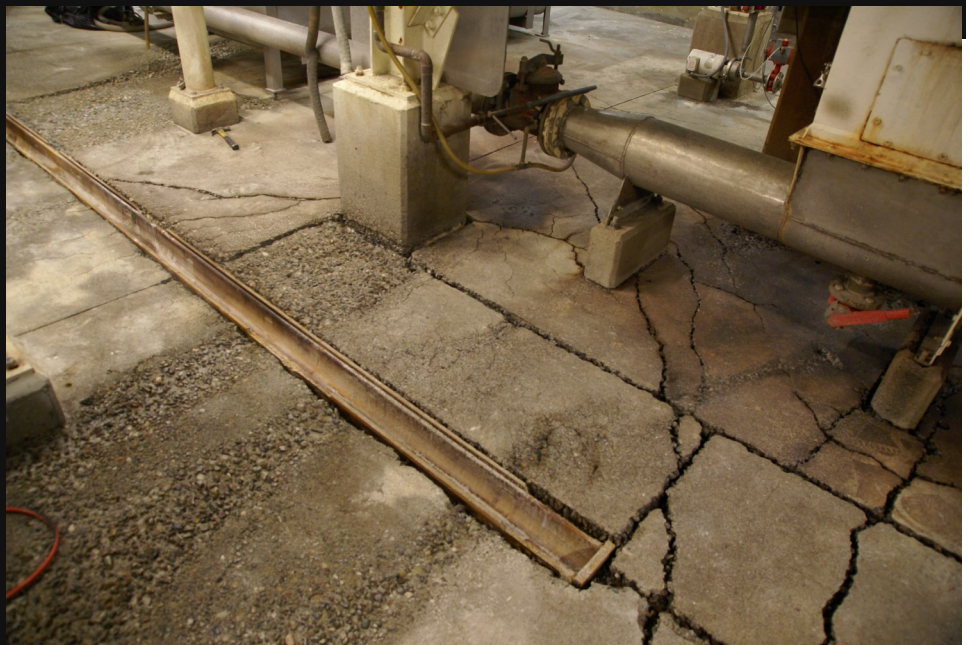
A Northern California Brewery had a serious erosion problem in one of they're processing area's. As you can see, the concrete was severely eroded and actually had rebar showing through in places. The owners wanted to repair the damage and have a flooring system installed that would hold up to the chemical attack, in the area. The flooring system was comprised of a high strength repairs mortar to repair the cracks and erosion followed by Tnemec's 245, a high quality Urethane Cement. The work was done in two days, the first consisted of cleaning and scarifying the concrete as well as installing the repair mortar. The Urethane Cement was applied 1/4" thick and a light broadcast of white aluminum oxide was applied to provide additional slip resistance. The project was completed Sunday evening and put back into service Monday morning.
