US Coatings Corporation

Case Study

Sump Pit Rehabilitation

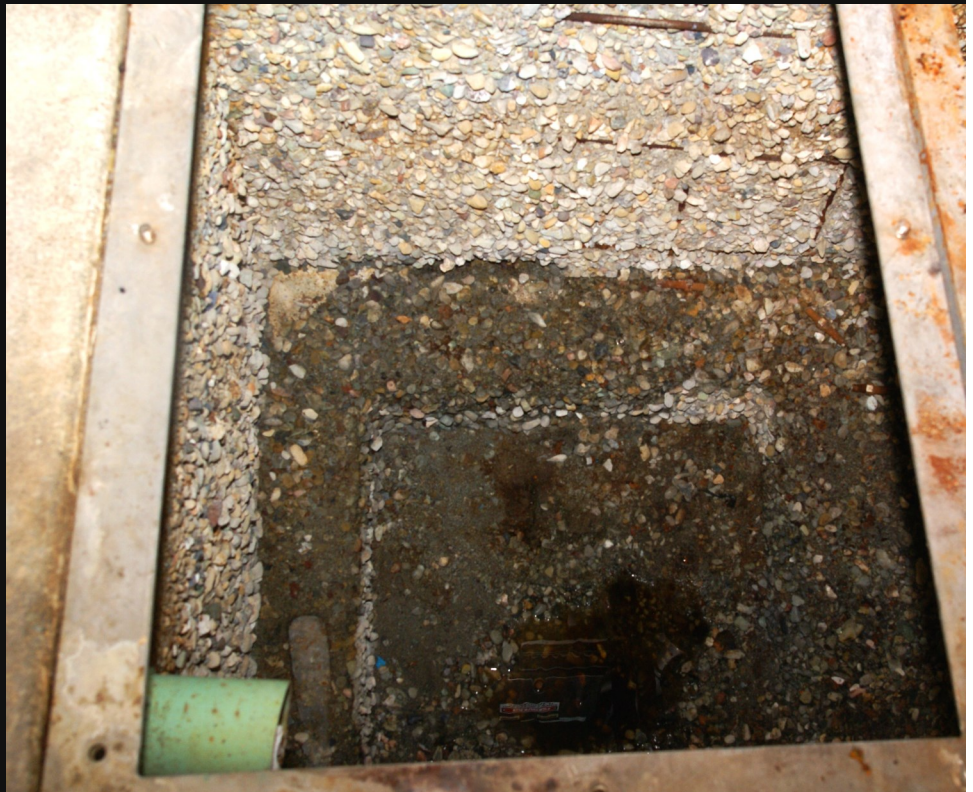
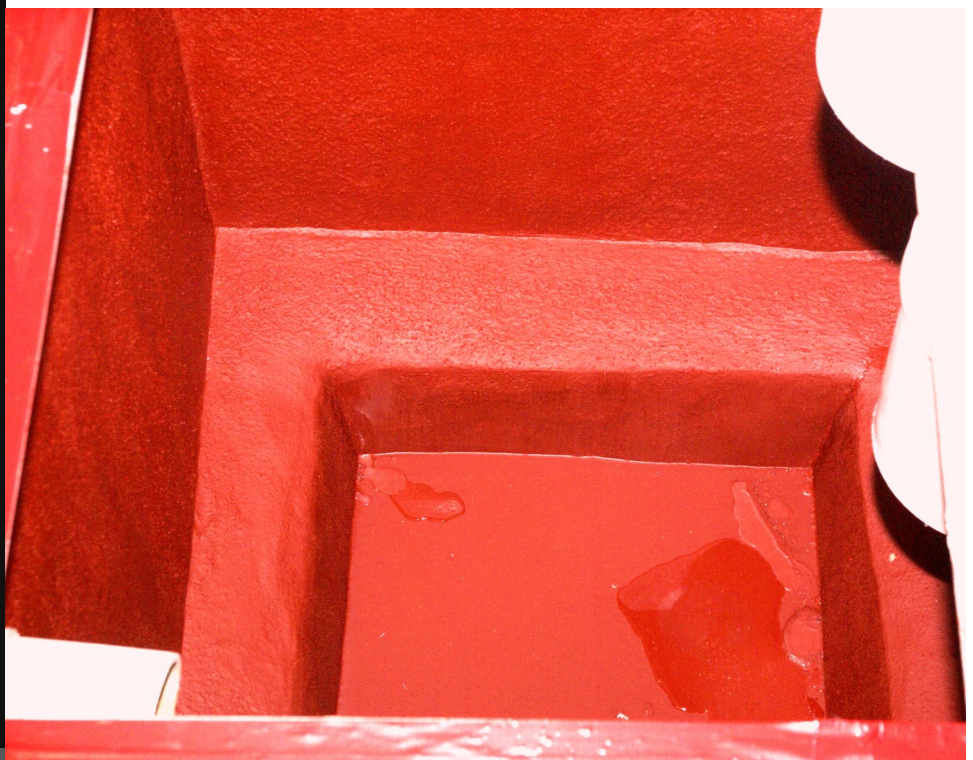
The pictures pretty much tell the story here, this sump pit was dried, cleaned, scarified and trowelled with a high strength repair mortar. The mortar was allowed to dry for four hours, lightly diamond grinded and trowelled with Tnemec 243 a vertical grade Urethane Cement. The entire project was completed in one day and put back into service the following morning.

ASTM 4259 Standard Practice for abrading concrete

Tnemec 243 Urethane Cement Vertical Mortar
